Aloha boathouse

BOATHOUSE RESTORATION, CABINETRY, AND FINISHING

Kirby Perkins Construction, Middletown, R.I.; kirbyperkins.com

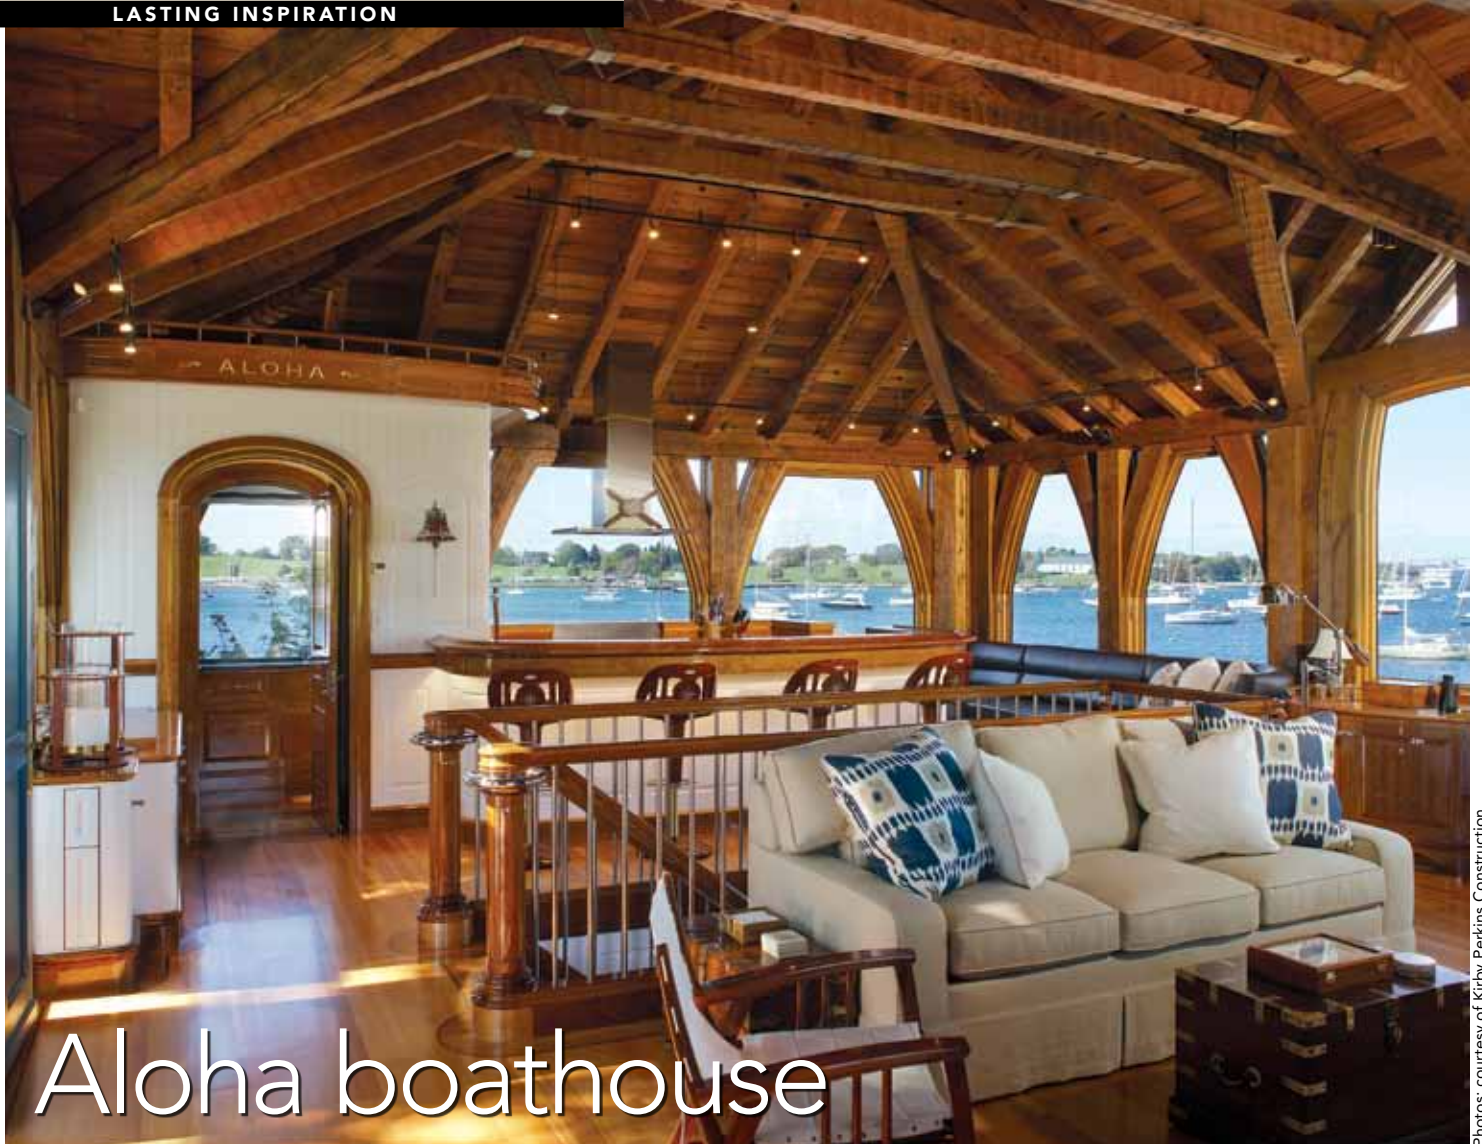
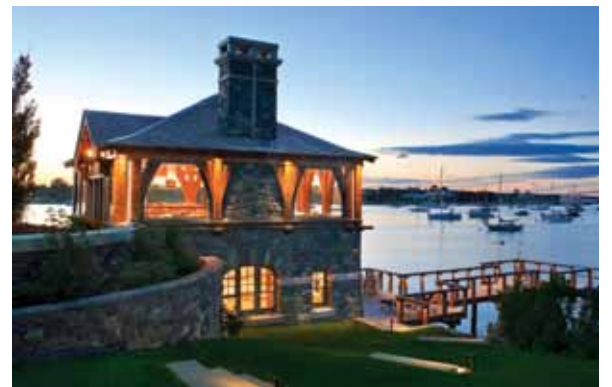
Built in 1911, this stone-and-timber boathouse sat unused for years and fell into disrepair. Its chestnut roof framing and ceiling and oak post-and-beam framing were rotting, and its foundation was crumbling. The boathouse was purchased a few years ago by an avid yachtsman who was determined to return it to its former grandeur. Located on the coastline of Newport Harbor, R.I., it was in the perfect spot to get the attention it needed from the restoration specialists at Kirby Perkins Construction. Using a satellite tracking system, they tagged all of the beams, removed and transported them to their shop, and restored each one that

could be salvaged. An antique-lumber dealer provided replacements for those beyond repair. When the foundation was secure, the beams were reinstalled. With the foundation and beams repaired, Kirby Perkins carpenters and finishing specialists turned their attention to the interior. Designed in the trademark style of Capt. Nathanael G. Herreschoff, a famous Rhode Island naval architect, the second-floor living space features white paneling with cherry cabinets and trim. To obtain the perfect gloss on the wood, the finishing team hand-applied eight to 10 coats of Epifanes UV gloss varnish, hand-sanding between each coat. —Maureen Friedman
